Public Buildings Enhanced Energy Efficiency Program

Final Report Investigation Results For AASF Holman Field

AASF Holman Field Energy Investigation Overview

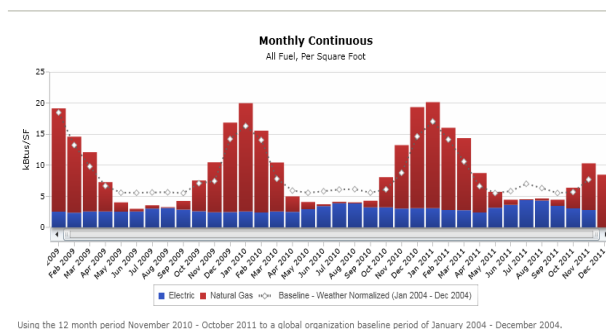
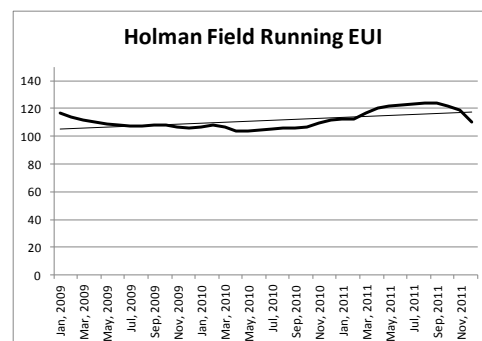
STATE OF MINNESOTA B3 BENCHMARKING

AASF Holman Field Consumption Report
Total energy use rose 14% during the period of the study
